W.J. JOHNSON & ASSOCIATES

**SUBJECT: HB-4D Phase One Milestone Inspection
PL20230005637
Vanderbilt Yacht and Racquet Club Condominium Association, Inc.
Project #: 02099.11**

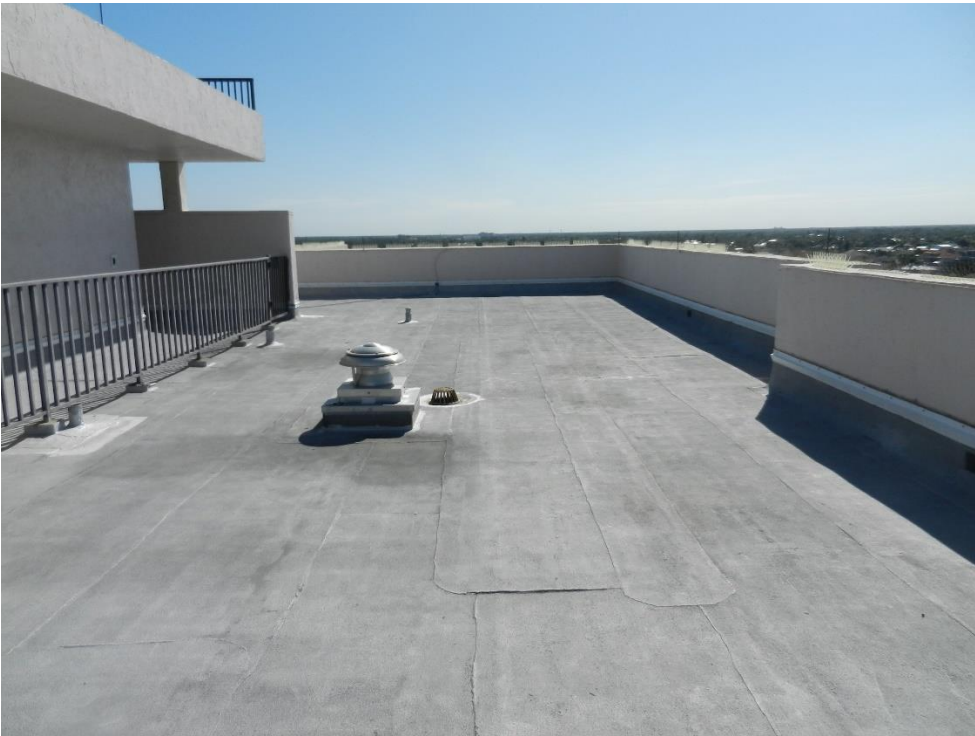
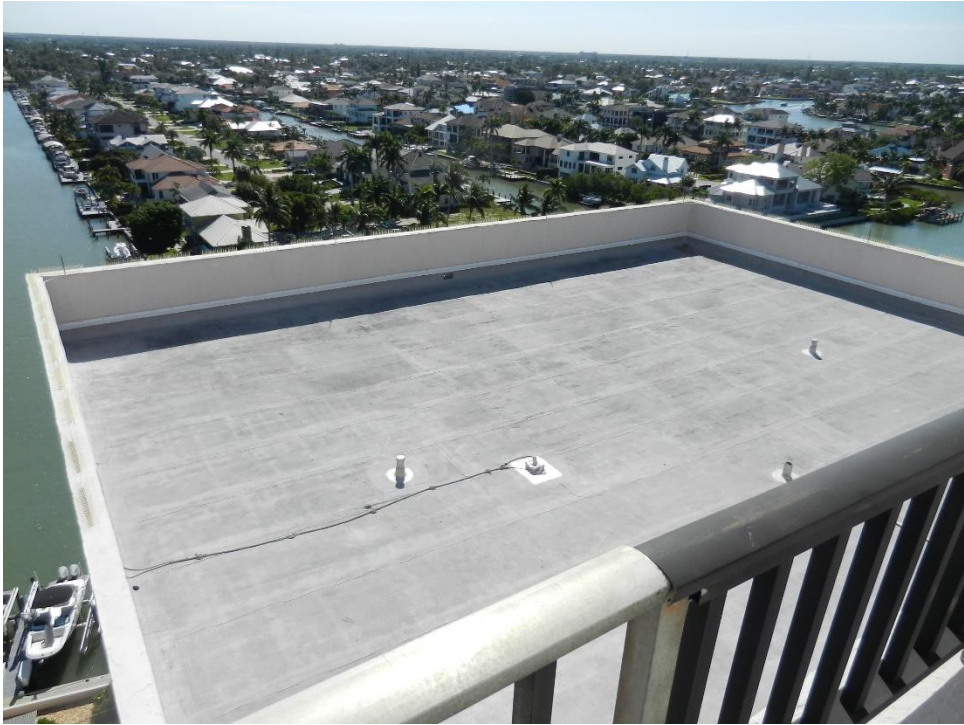
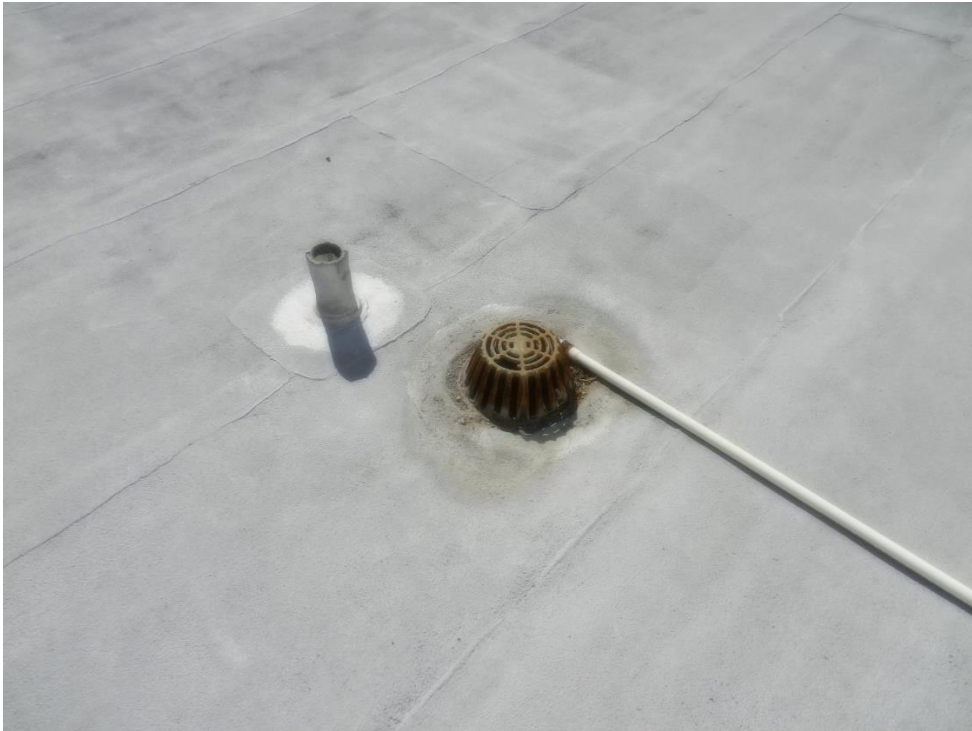
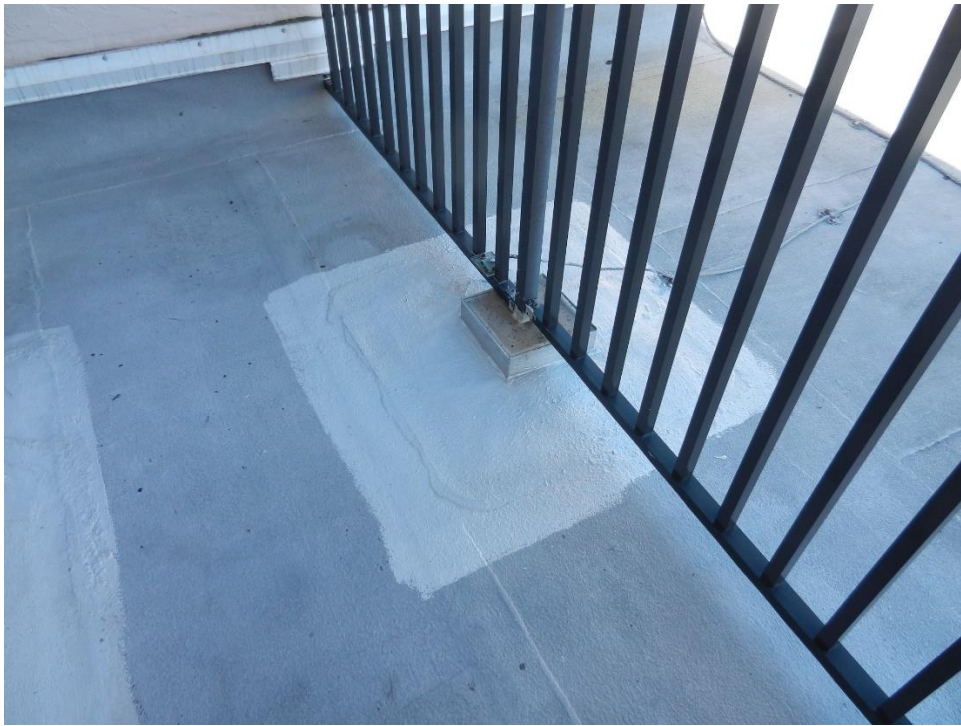
Areas of Maintenance

The existing roof is a modified bitumen system that was installed in 2010 to replace the existing roof. This roof is inspected on a yearly basis by the installer, Advanced Roofing & Sheetmetal. The roof shows signs of recent patching and maintenance. The roof is scheduled for replacement in 2026. The HVAC condenser sleepers are showing signs of deterioration and are scheduled for replacement in conjunction with the roof replacement. The roof is pitched to an interior drainage system with overflow scuppers. The roof is in good condition, however, there are several areas along the parapet lashing that are showing signs of potential failure. These areas should be inspected and repaired prior to the upcoming rainy season.

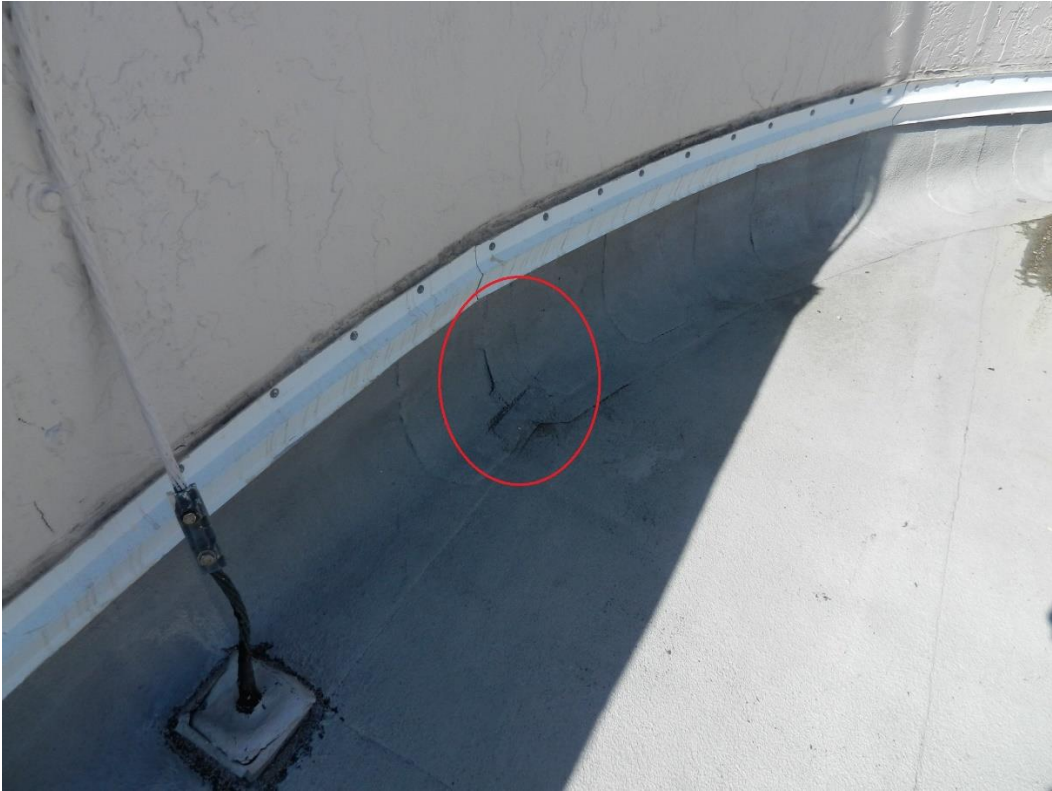
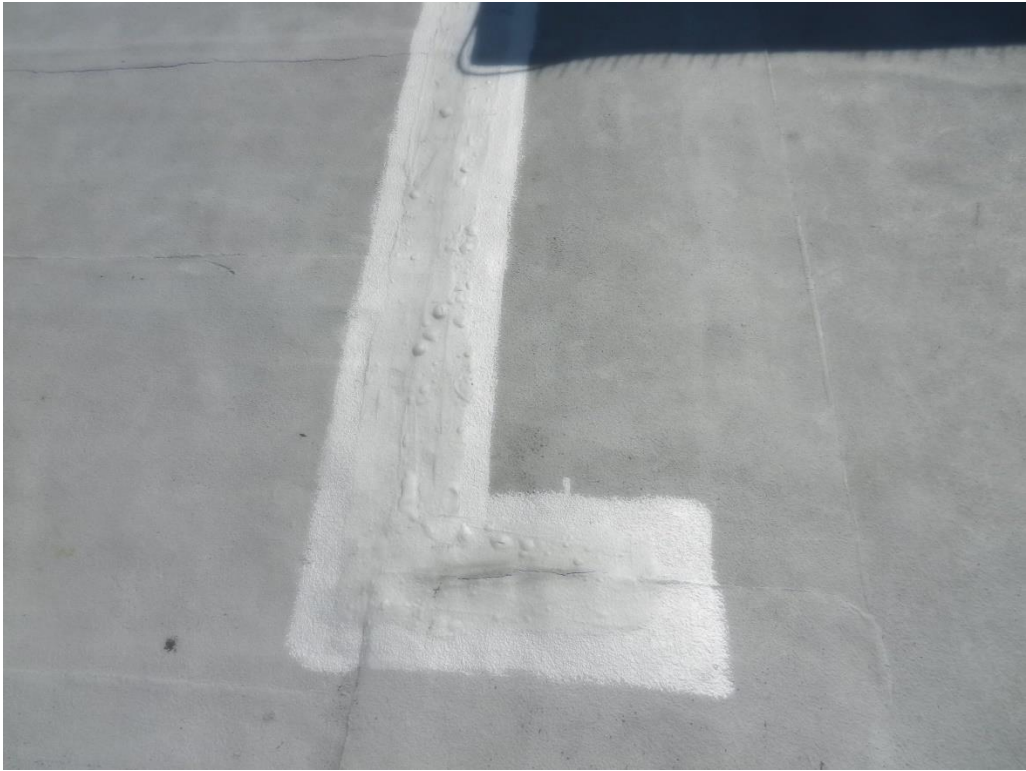
Potential Roofing Failures

- Concrete deterioration should be addressed within the next 12 months.
- The lanai crack should be addressed as soon as possible.
- The roof should be inspected and repaired prior to the 2024 rainy season.

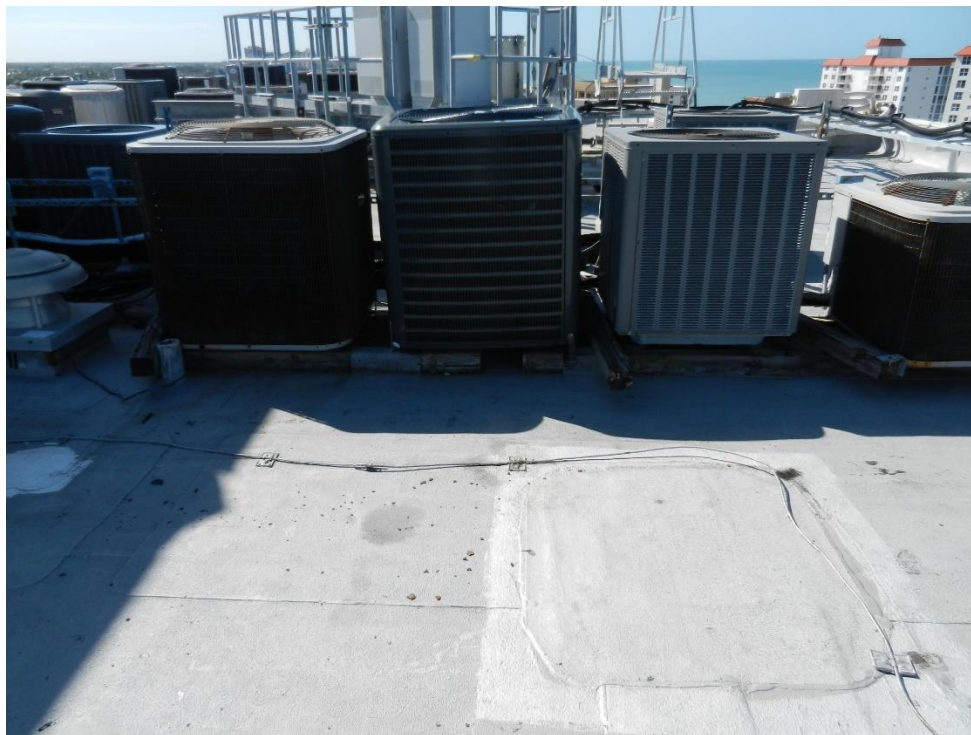
Deteriorating HVAC Support

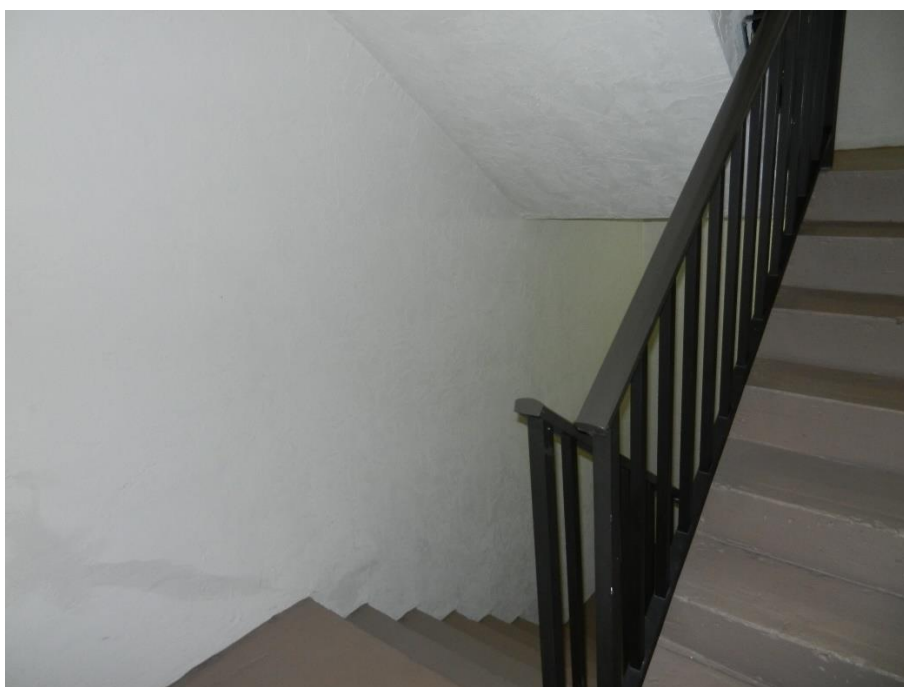
There are two sets of fire resistive exit stairwells. This allows for two means of egress for all of the residential units. All of the doors at the North stairwell have been replaced. The South stairwell doors have not been replaced. These stairwells are in good structural condition.

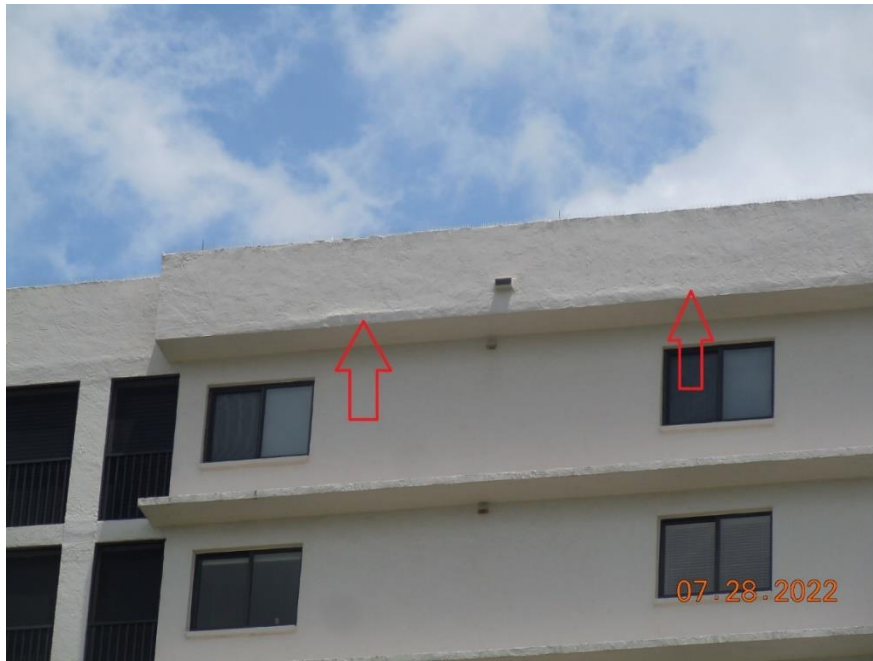
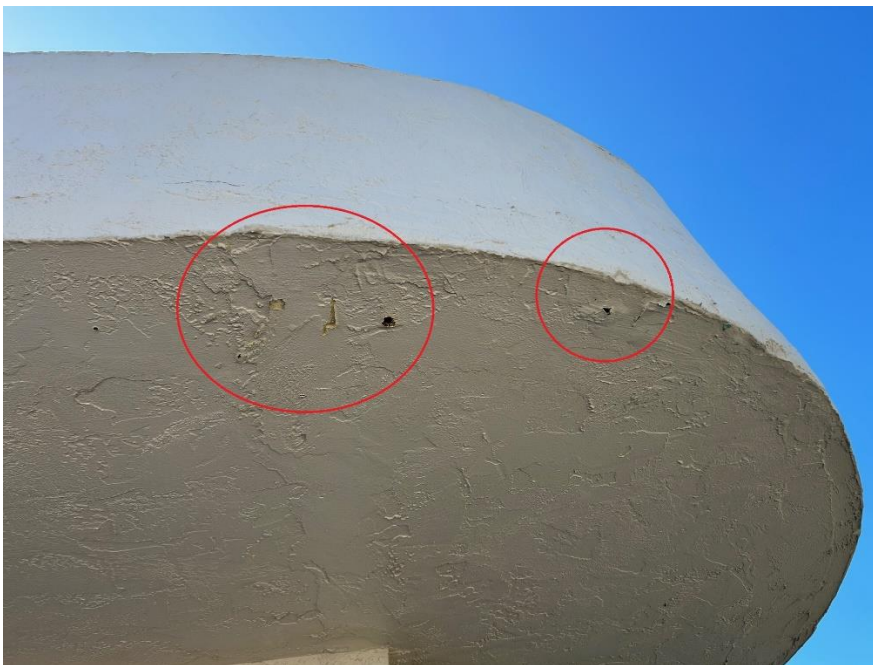
- Several areas at the roof parapet wall display evidence of water intrusion between the concrete deck and the masonry. This should be addressed when the roof is replaced within two years and the building painted.

Deteriorating Concrete and Rebar North East Corner of the Roof Deck

- Concrete repairs may require a building permit from Collier County.
- The Parapet wall to slab transition should be addressed at the time of the new roof and painting.

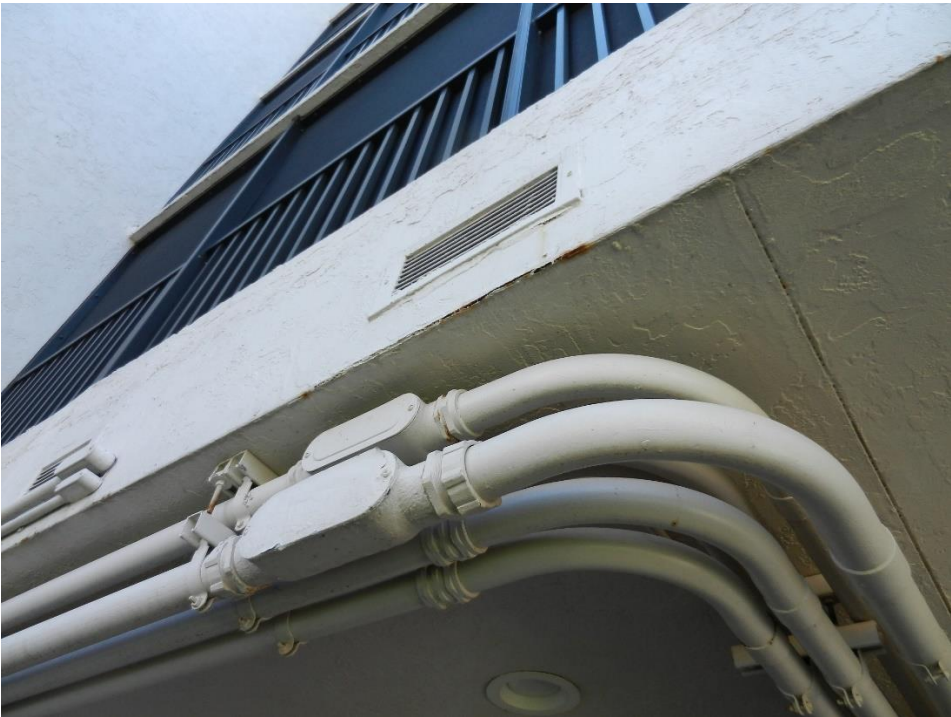
Rust Stains at the Northwest and Southwest First Floor Overhang

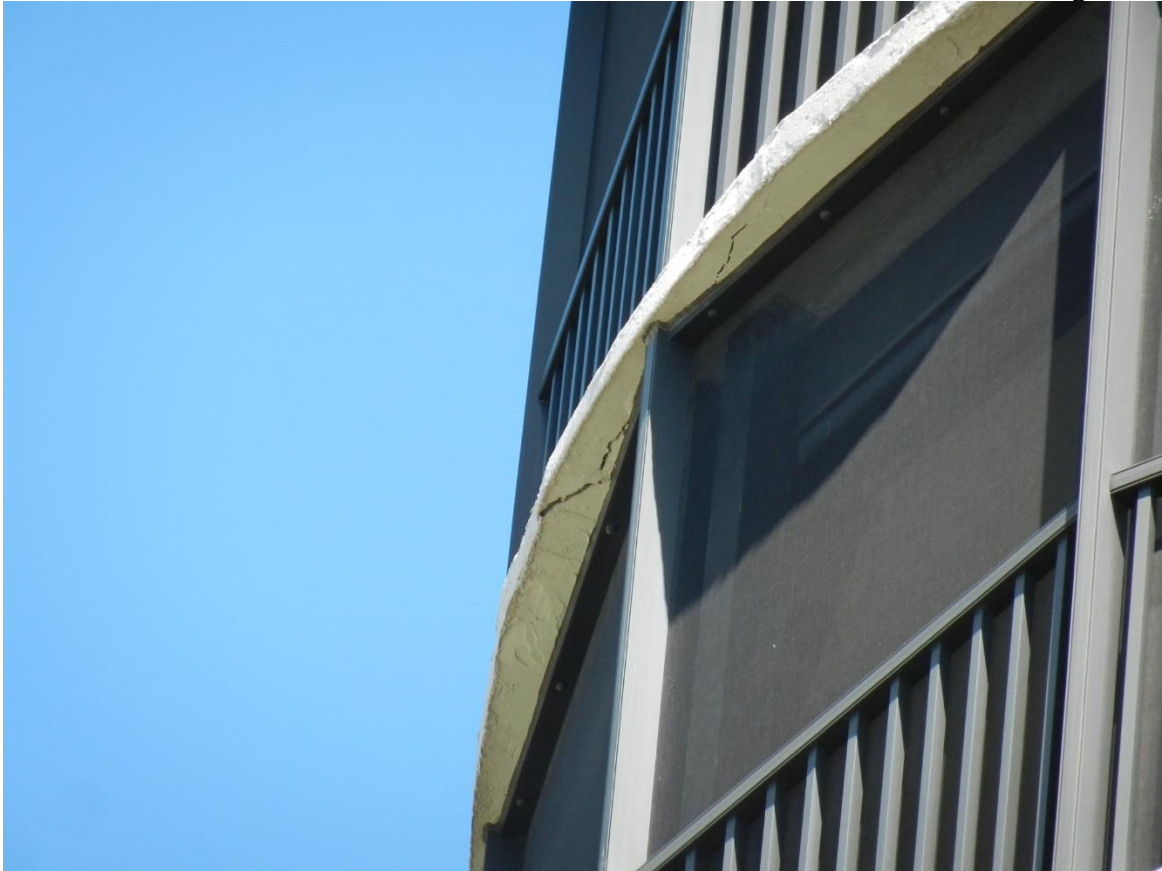
Lanai Deck Crack at Unit 903

- The lanai slab repair should be completed as soon as possible. Once completed, the Engineer providing the Milestone Inspection report must provide an amended report indicating that the building is safe for continued use under the present occupancy.

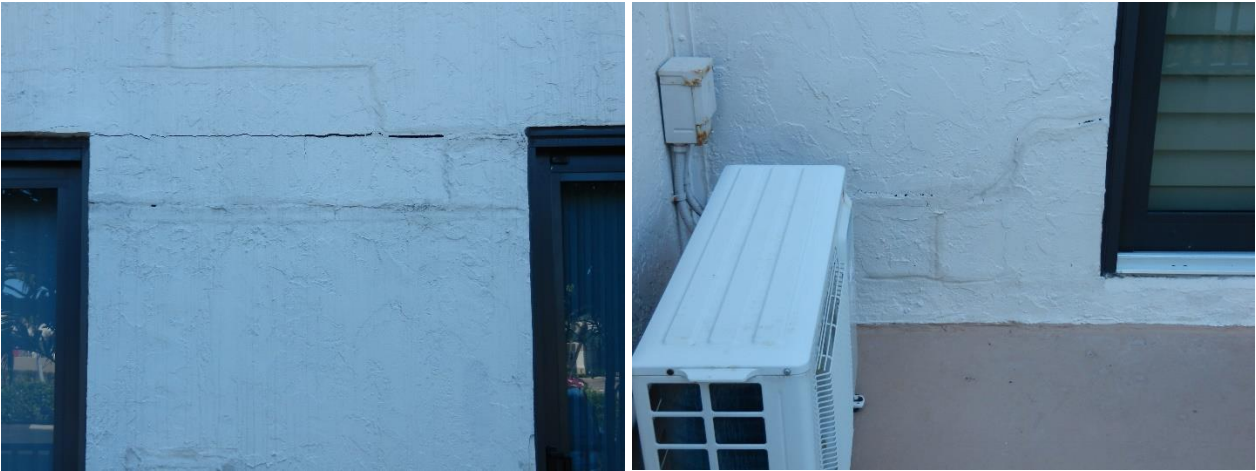
Continued Settlement at the Ground Floor Cabanas
