# Vanderbilt Yacht & Racquet Condominium Association, Inc.

STRUCTURAL INTEGRITY  
RESERVE STUDY

Vanderbilt Yacht & Racquet Club Condominium Association, Inc.  
Naples, Florida

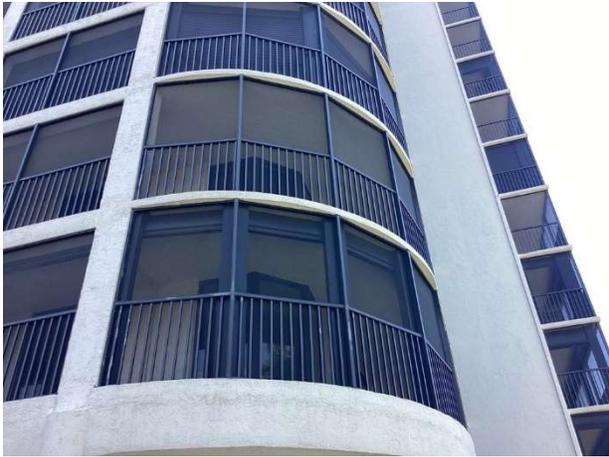
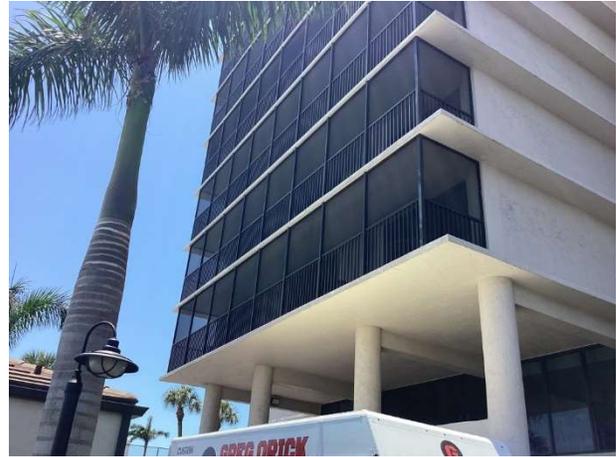
**Condition:** Good overall

**Balcony overview**

**Useful Life:** Capital repairs including a close-up visual inspection, patching of delaminated concrete, routing and filling of cracked concrete, and waterproof coating applications every 10- to 15-years.

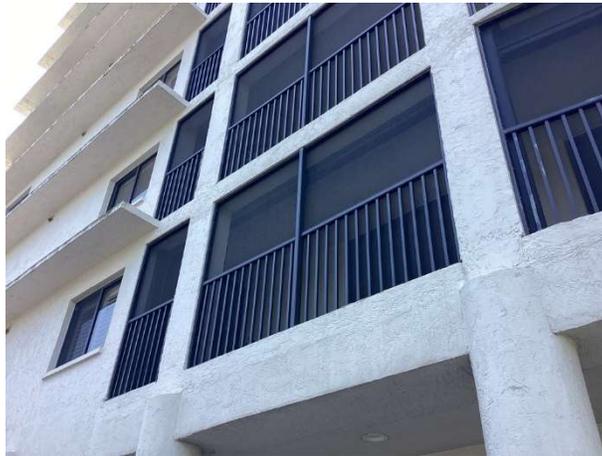
**Condition:** Good overall

**Aluminum railings**

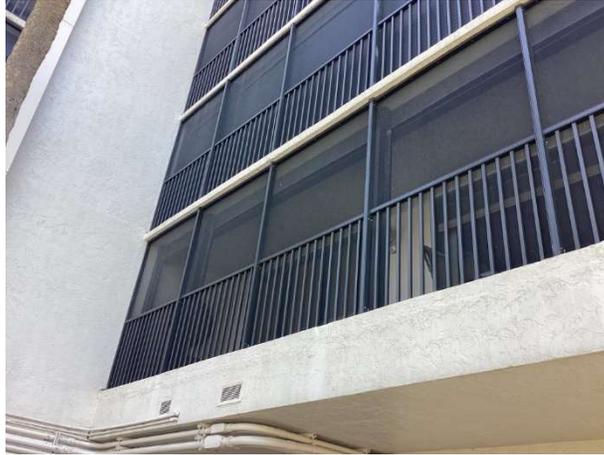
**Condition:** Good overall

**Balcony screens and frames**

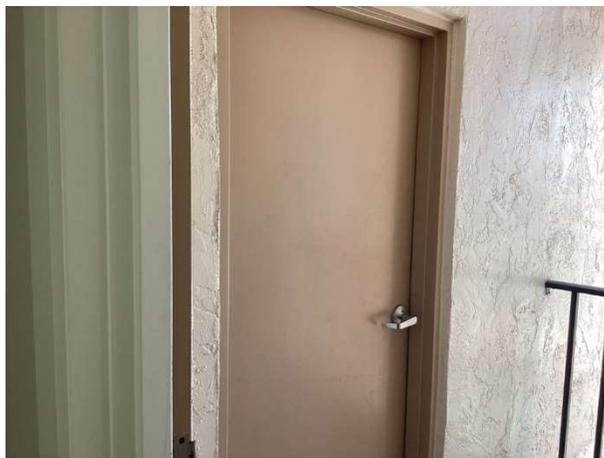
**Condition:** Good overall

**Stairwell entrance doors**

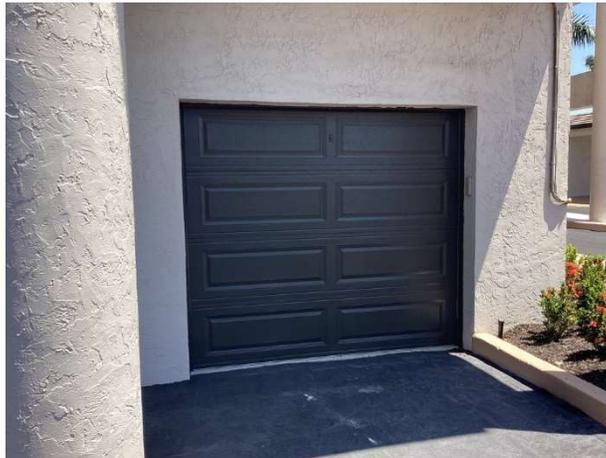
**Condition:** Good overall

**Garage doors**

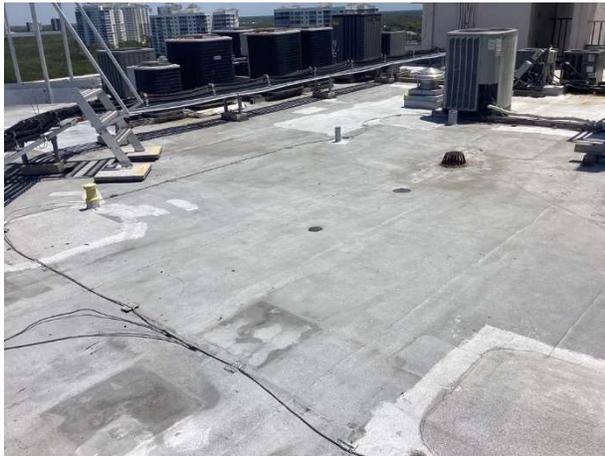
**Condition:** Fair overall with evidence of standing water and patches evident. Management and the Board do not report history of leaks.

**Modified bitumen roof overview**

**History:** Reportedly original. We recommend the Association should conduct inspections of the roofs semiannually and fund these inspections through the operating budget.

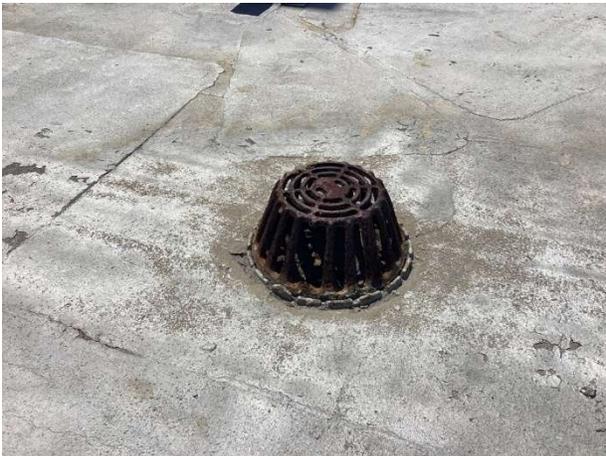
**Rust at roof drains**

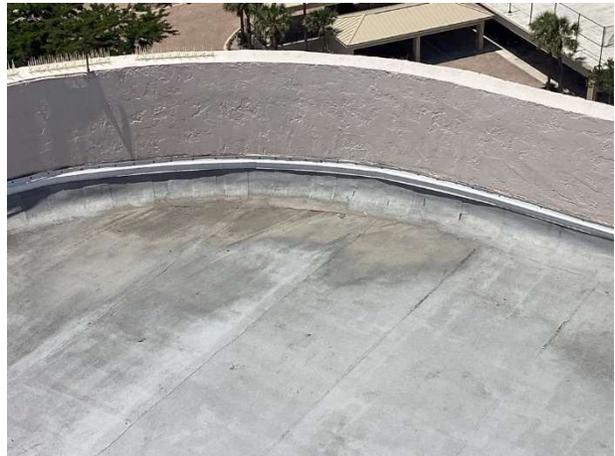
**Evidence of standing water**

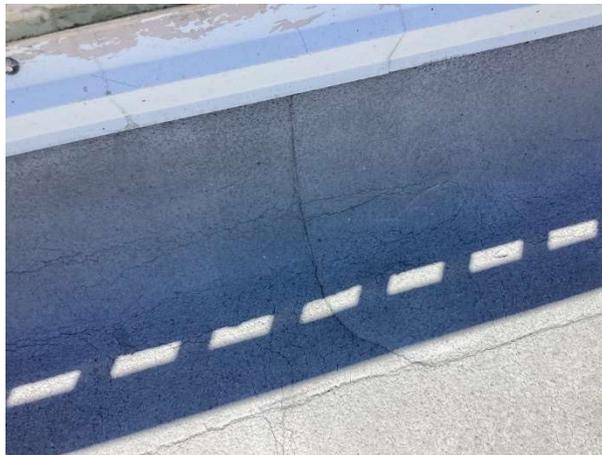
**Roof cracks at parapet wall**

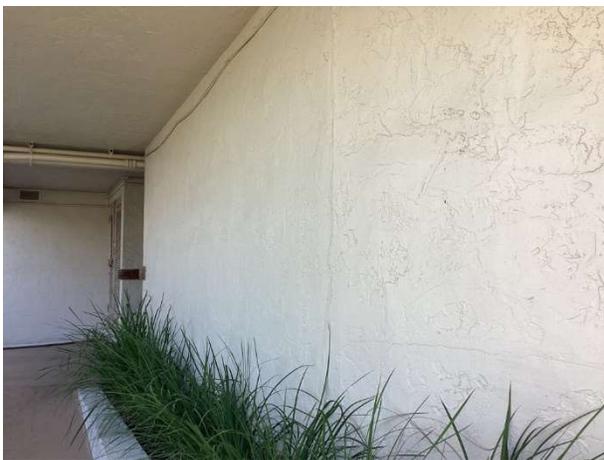
**Condition:** Fair overall with isolated cracks evident.

**Stucco wall finishes**

***Useful Life:*** We recommend inspections, repairs and paint finish applications every five- to seven-years.

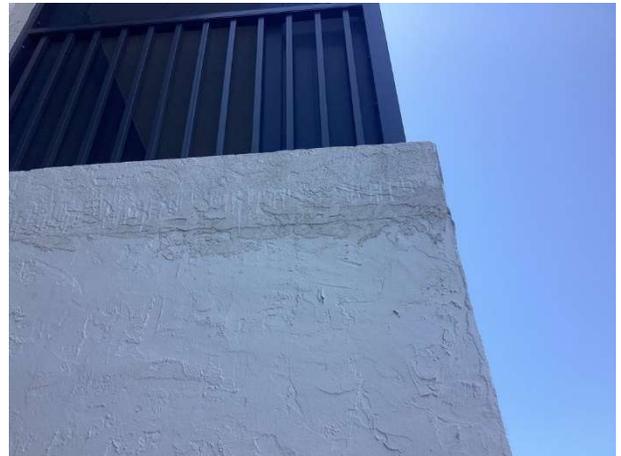
**Stucco cracks**

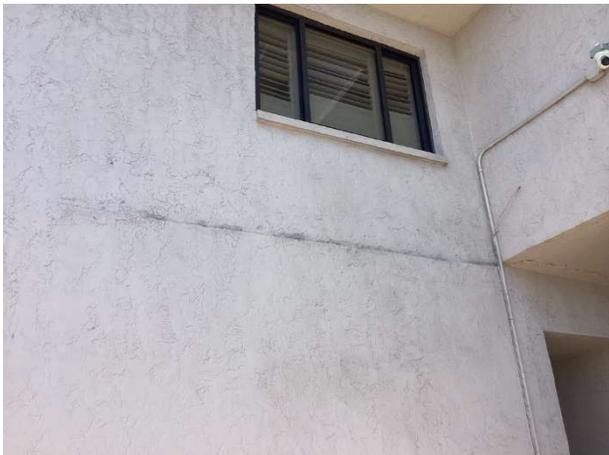
**Stucco cracks**

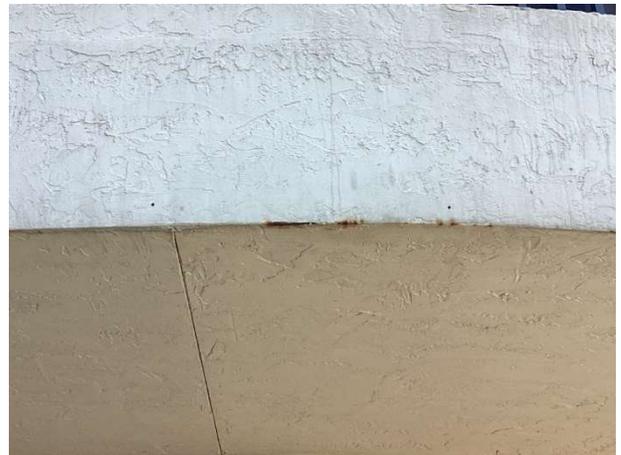
**Rust at bead joint**

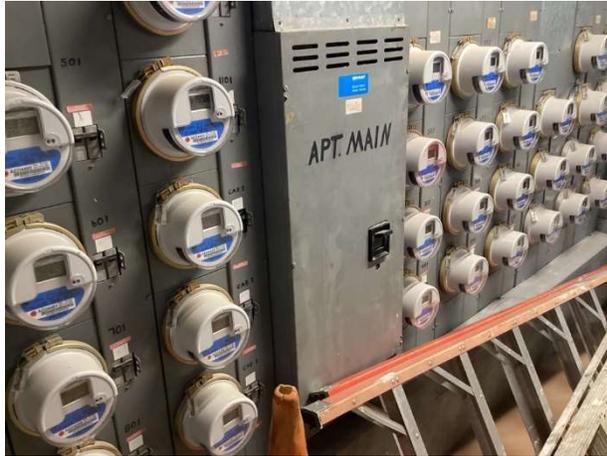
**Condition:** Reported satisfactory without operational deficiencies.

Electrical system main panels

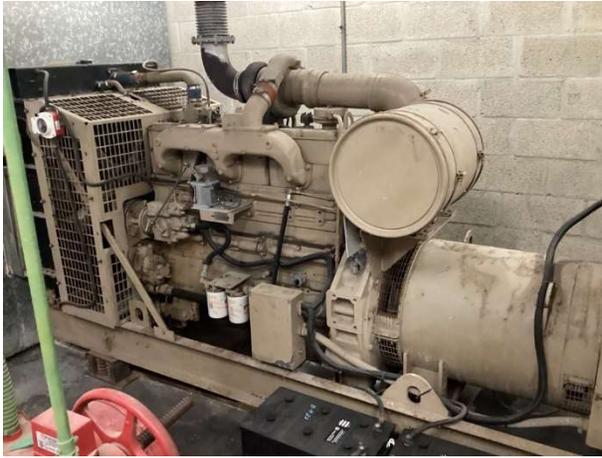
**Condition:** Reported satisfactory without operational deficiencies

**Generator**

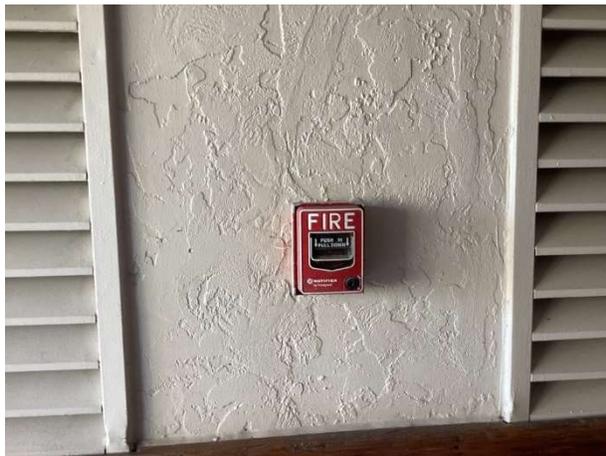
**Conditions:** Reported satisfactory without operational deficiencies.

Emergency devices

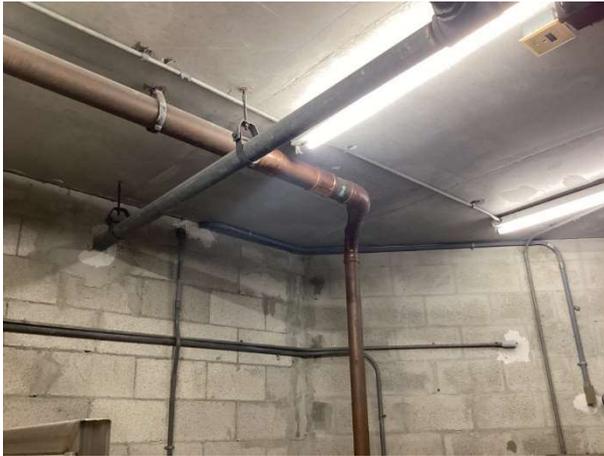
- Domestic Water – Reported satisfactory with operational deficiencies
- Sanitary Waste Disposal and Vent – Reported satisfactory

**Domestic water pipes**

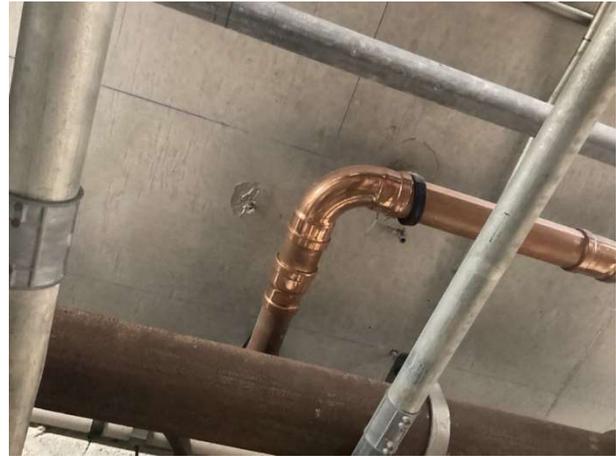
**Evidence of isolated partial replacements at domestic water pipes**

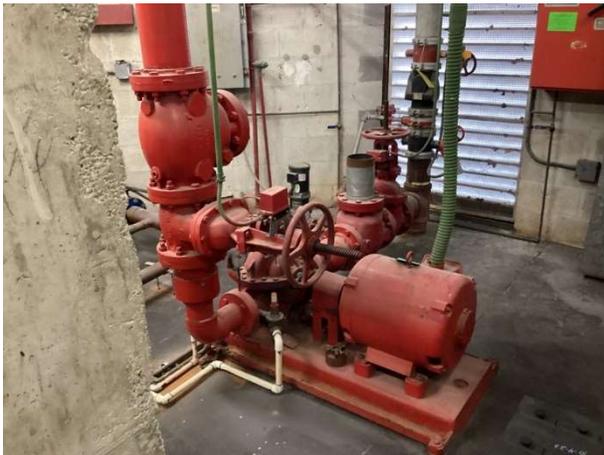
**Condition:** Reported satisfactory without operational deficiencies.

**Fire suppression pump**

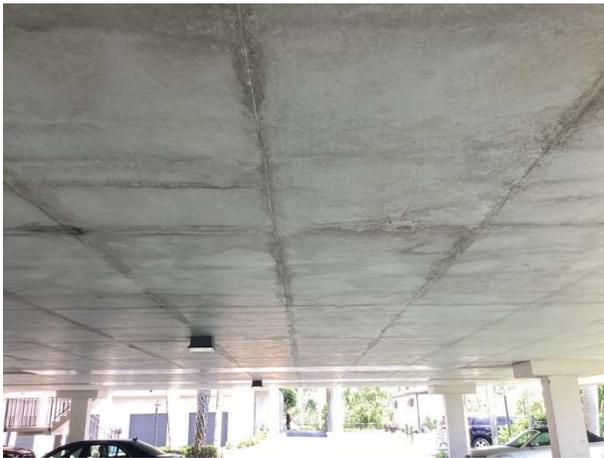
**Condition:** Fair overall with isolated cracks evident. The elevated structural concrete does not utilize a protective traffic coating

**Elevated garage floor overview**

**Useful Life:** Repairs to the various concrete surfaces every 10- to 15-years

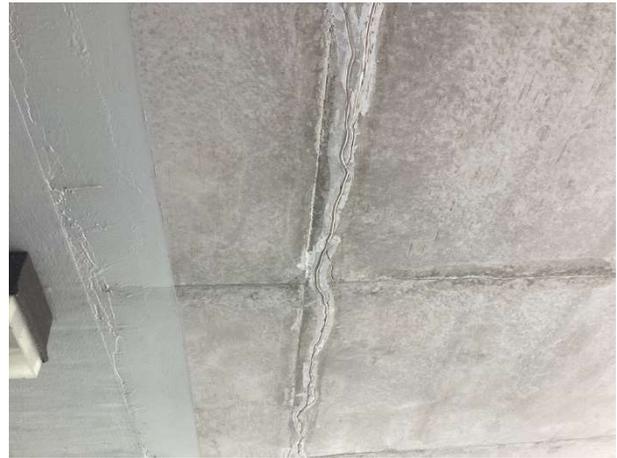
**Previous crack repairs**

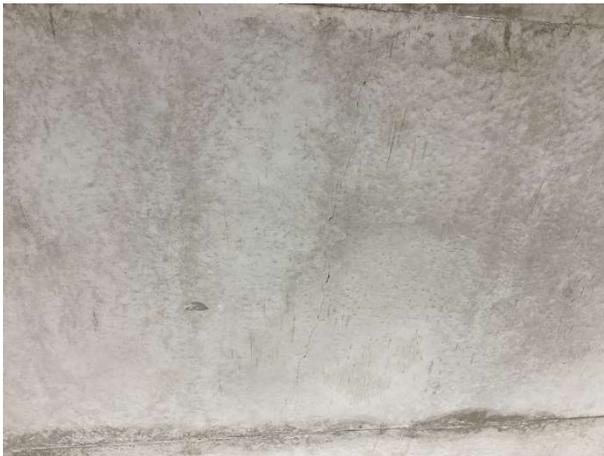
**Concrete cracks**

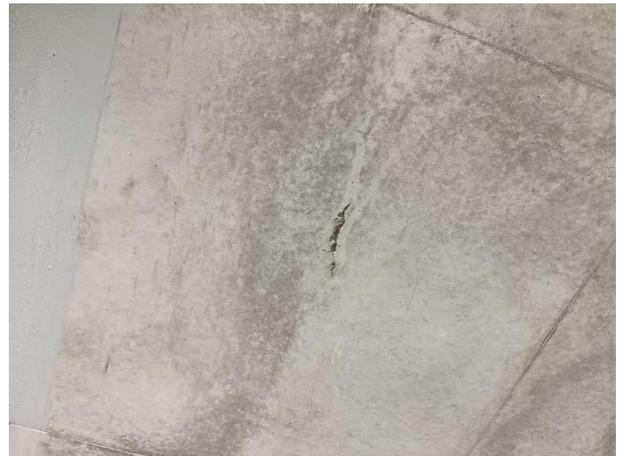
**Concrete honeycombing**

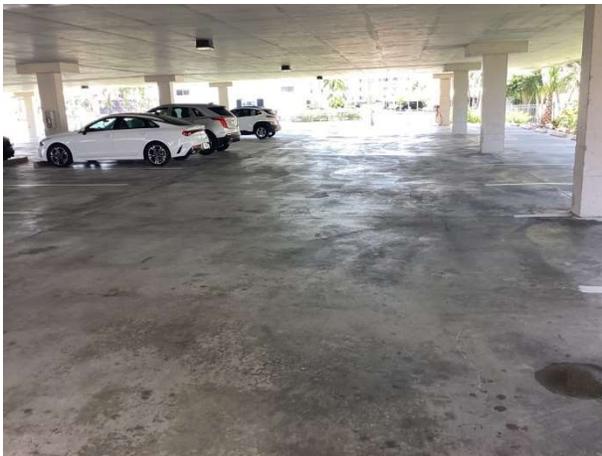
**Condition:** Good to fair overall with isolated concrete cracks evident

**On-grade garage floor overview**

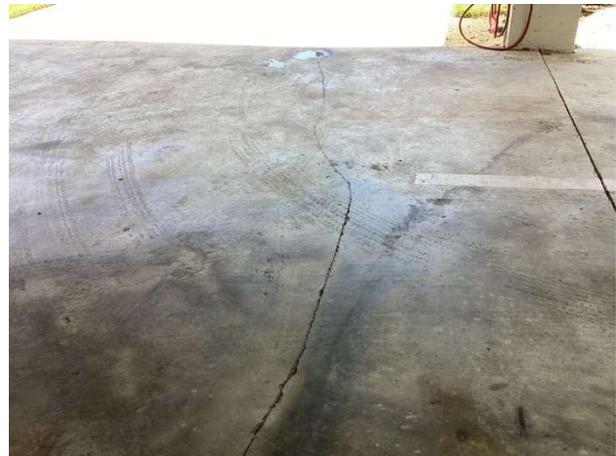
**Concrete cracks**

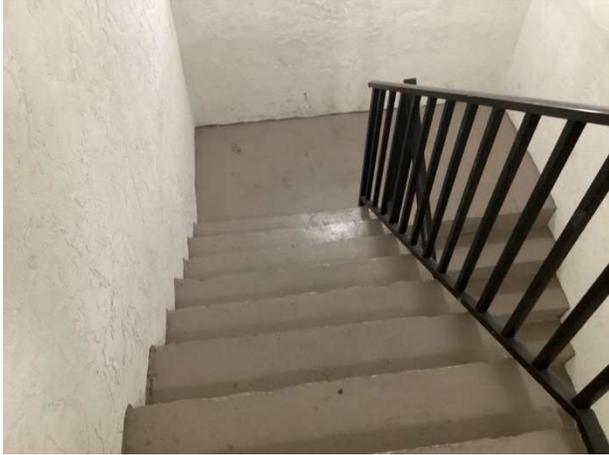
**Conditions:** Good overall with scuffs evident.

**Stairwell paint finishes**

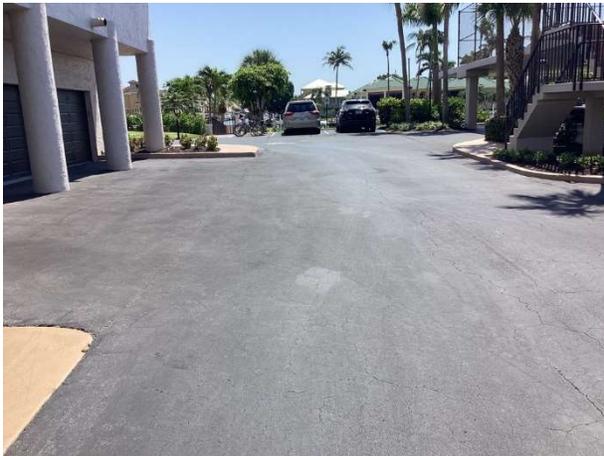
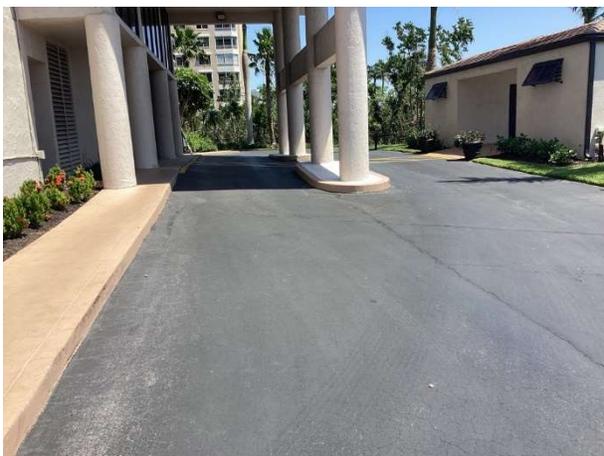
**Condition:** Fair overall with isolated cracks evident.

**Asphalt pavement street overview**

**Useful Life:** 15- to 20-years with the benefit of patch, seal coat, and striping events every three- to five-years

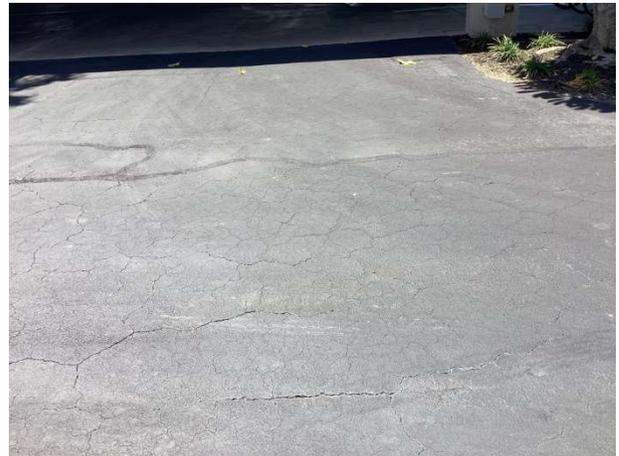
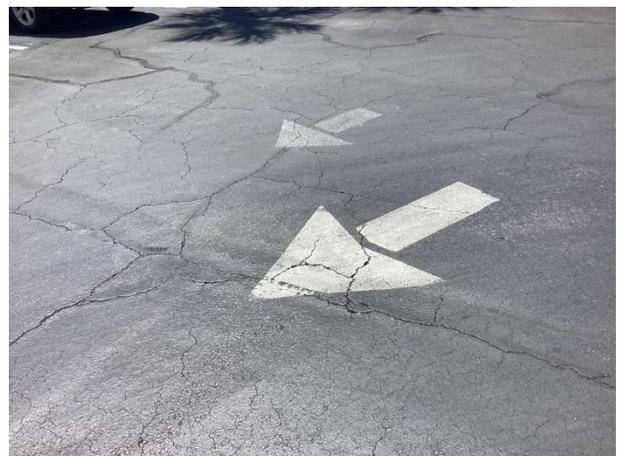
**Pavement cracks**

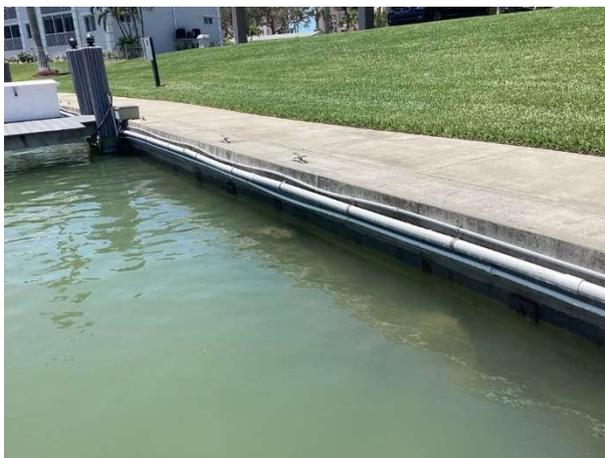
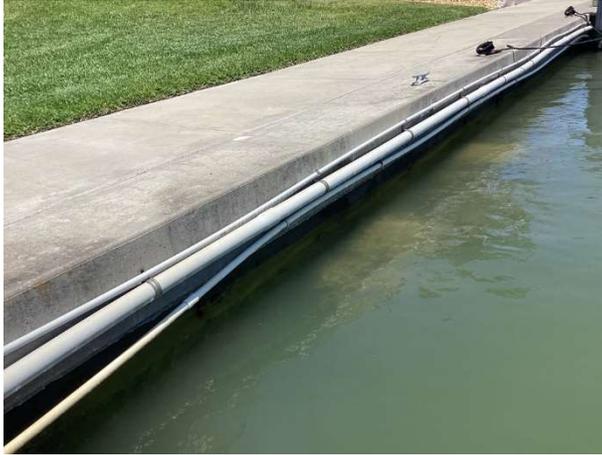
**Conditions:** Good to fair overall isolated wall cracks evident

**Concrete bulkhead overview**

**Useful Life:** Inspections and capital repairs up to every 15 years and complete replacement at up to 50 years

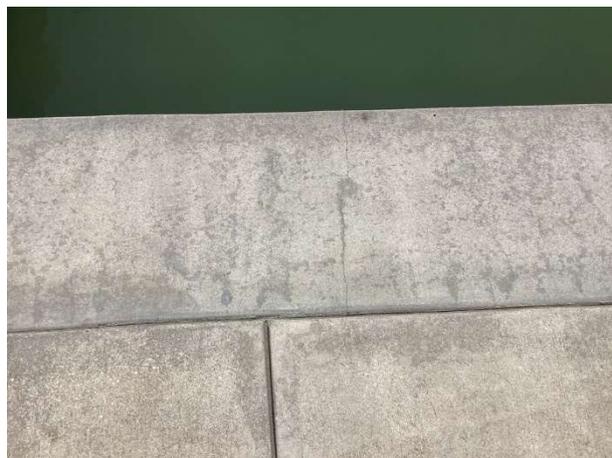
**Wall cracks**

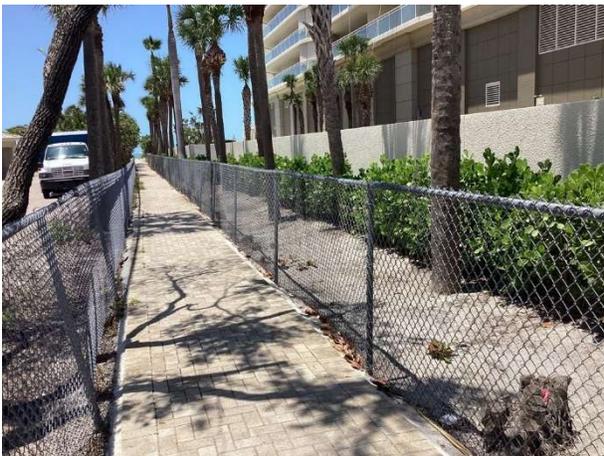
**Condition:** Fair overall with isolated leaning sections and warped webbing evident

**Chain link fence**

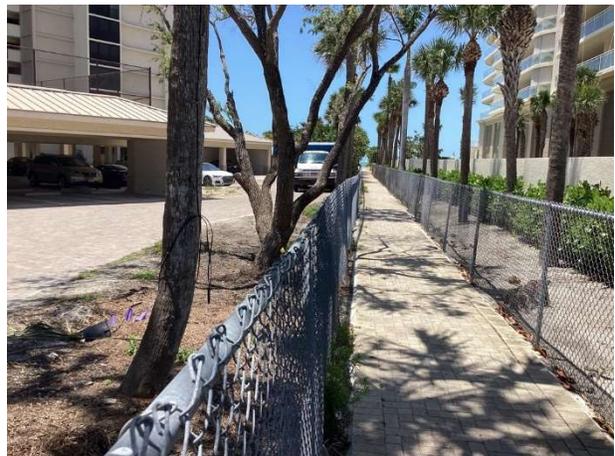
**Fence leaning section**

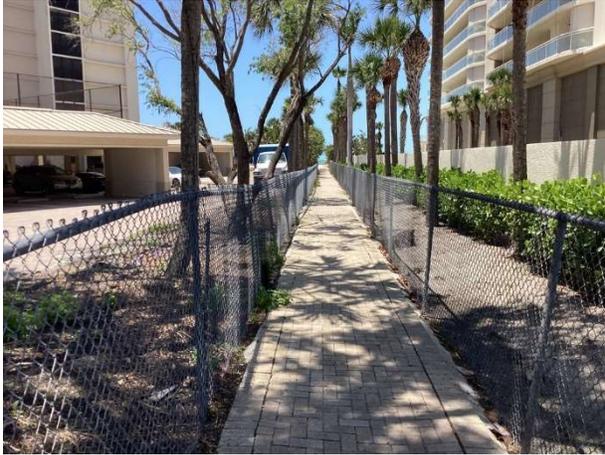
**Condition:** The pavers at the fire pit are in good overall condition. The pavers at the beach access walkway are fair to poor overall with dislodged pavers and settlement evident

**Masonry pavers overview at beach access walkway**

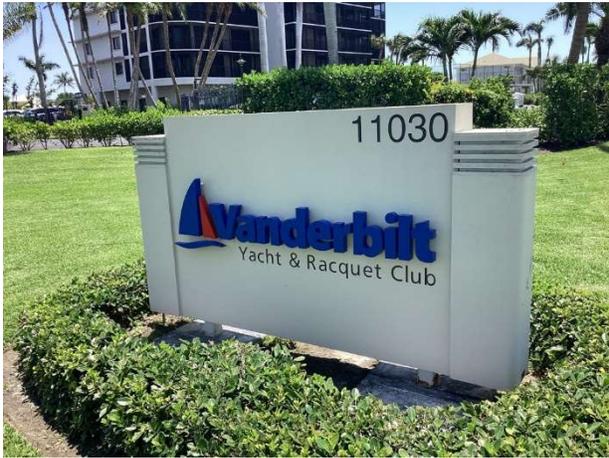
**Condition:** Good to fair overall with isolated peeled paint finishes evident

**Entrance monument**

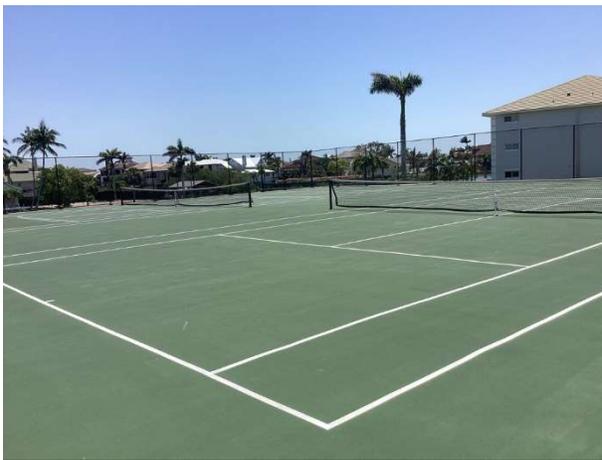
**Condition:** Good to fair overall isolated previous repairs evident

**Tennis courts overview**

**Useful Life:** We recommend the Association budget for color coat applications and repairs every four- to six-years

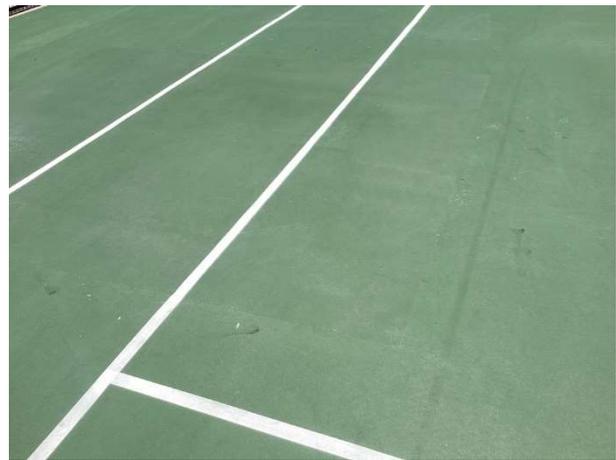
**Tennis court patch repair**
