W.J. JOHNSON & ASSOCIATES

**SUBJECT: HB-4D Phase One Milestone Inspection
PL20230005637
Vanderbilt Yacht and Racquet Club Condominium Association, Inc.
Project #: 02099.11**

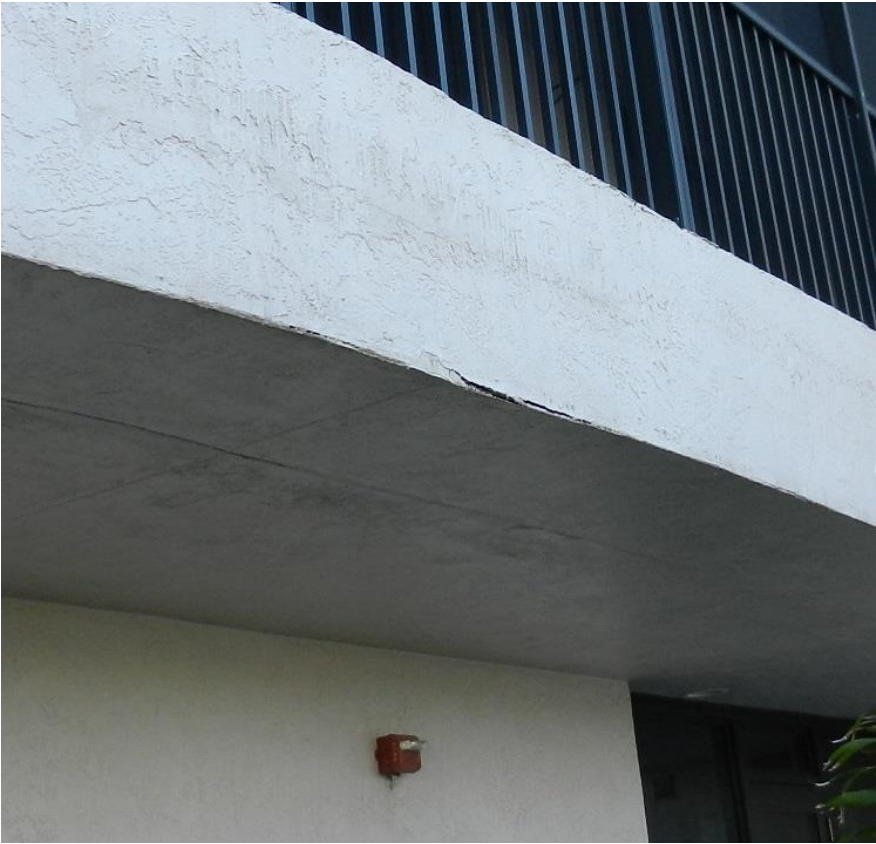
Rust Stains at the Northwest and Southwest First Floor Overhang

- Concrete deterioration should be addressed within the next 12 months.
- The lanai crack should be addressed as soon as possible.
- The roof should be inspected and repaired prior to the 2024 rainy season.
