# Vanderbilt Yacht & Racquet Condominium Association, Inc.

STRUCTURAL INTEGRITY  
RESERVE STUDY

Vanderbilt Yacht & Racquet Club Condominium Association, Inc.  
Naples, Florida

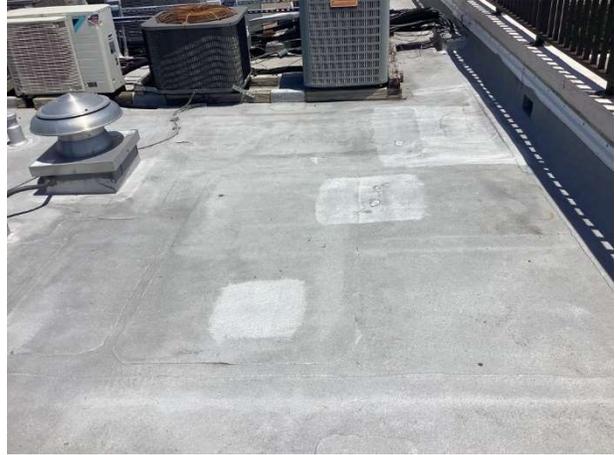
**Roof patches**

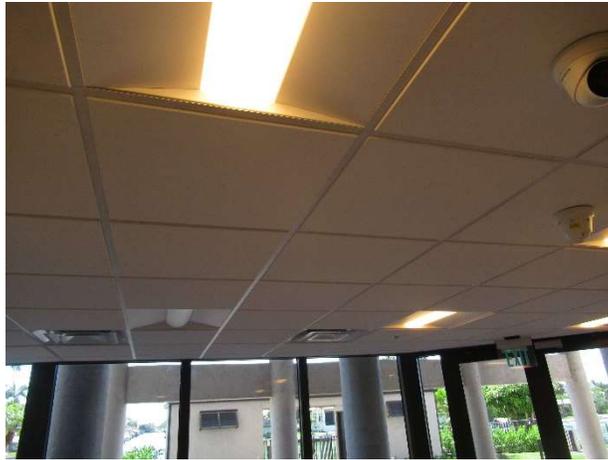
**Condition:** Good overall

Overview of acoustic ceiling tiles

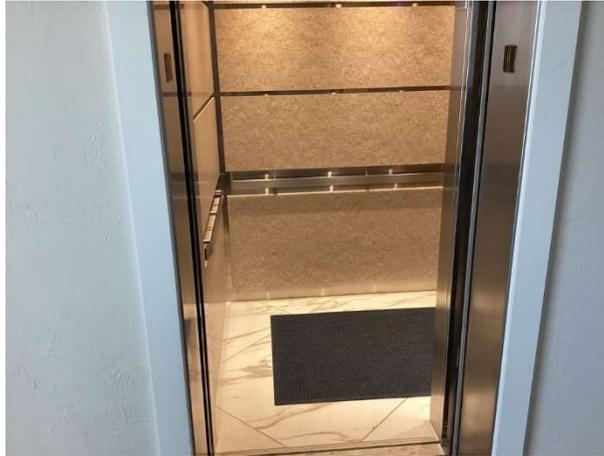
**Condition:** Good overall

**Elevator cab finishes**

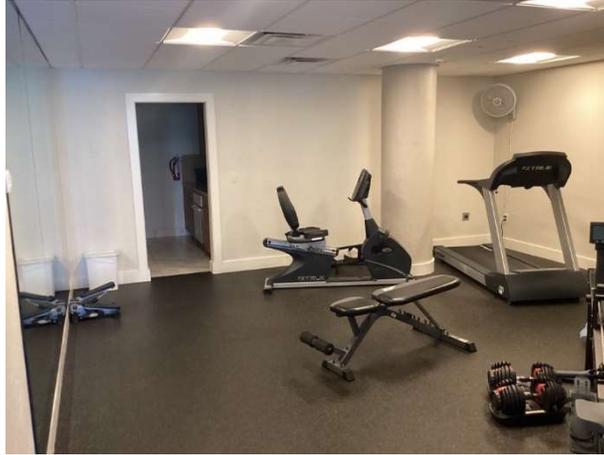
**Condition:** Good overall

**Exercise room overview**

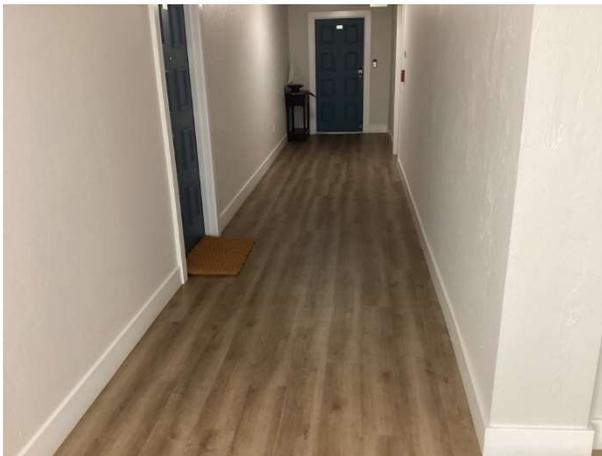
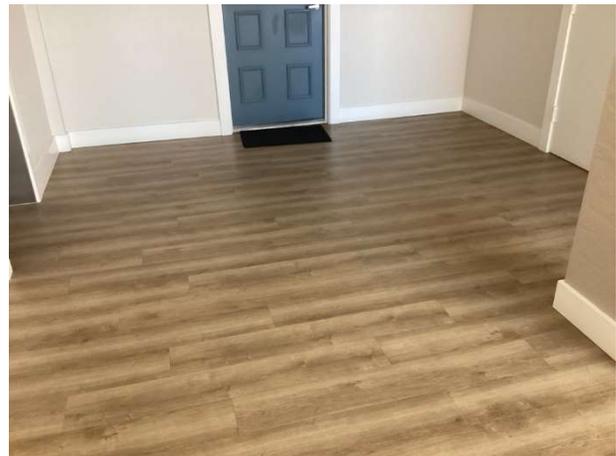
**Condition:** Good overall

**Wood floor coverings**

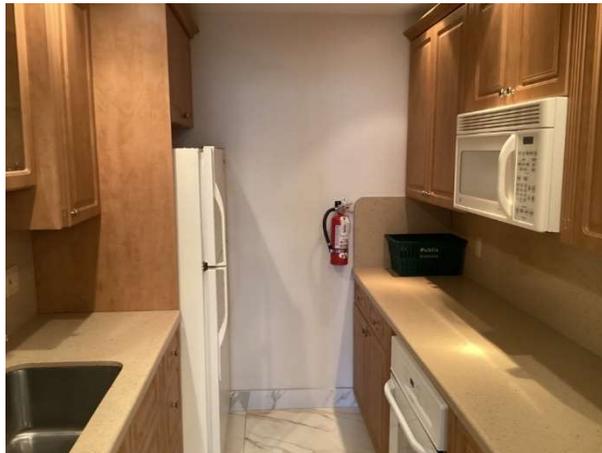
**Condition:** Good overall

**Kitchen overview**

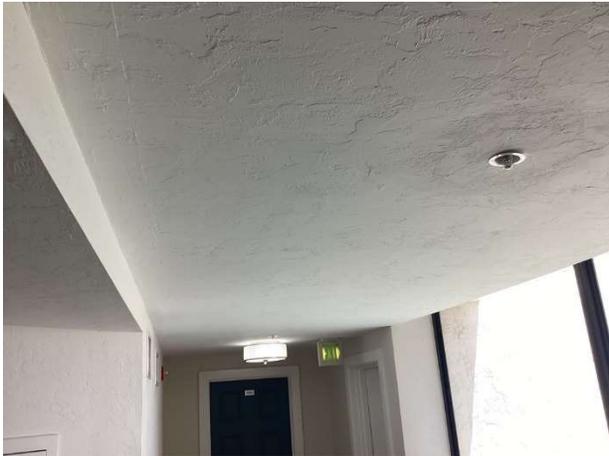
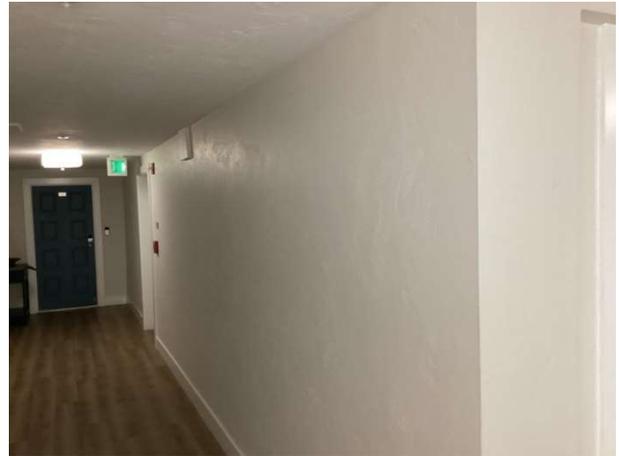
**Condition:** Good overall

**Paint finishes overview**

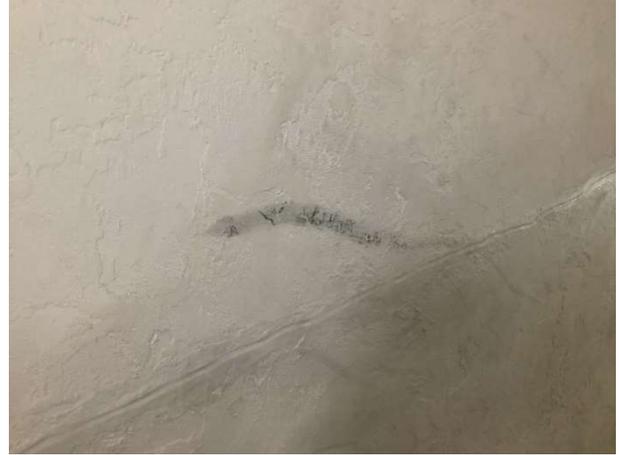
**Wall scuffs**

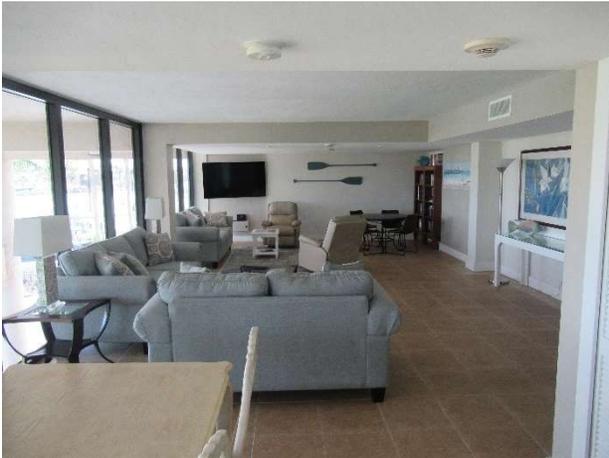
**Condition:** Good overall

**Party room overview**

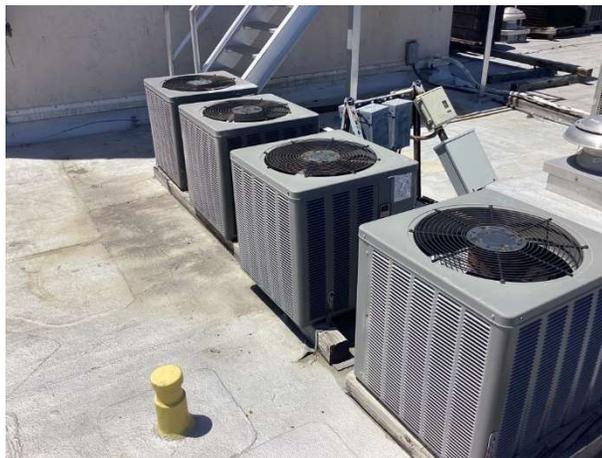
**Split system condensing units**

**Condition:** Reported satisfactory without operational deficiencies

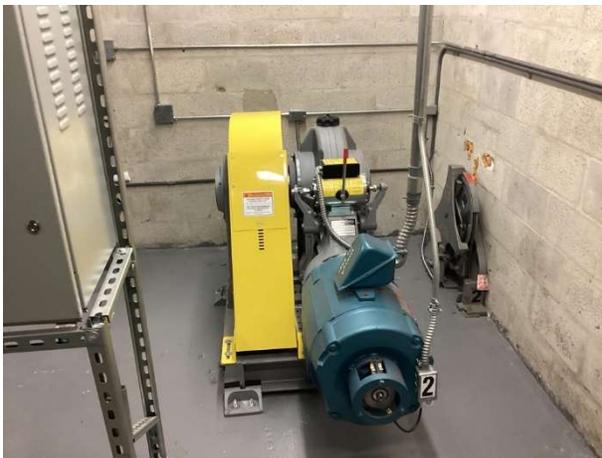
**Traction elevator hoists and motors**

**Condition:** Reported satisfactory and service interruptions are reportedly infrequent.

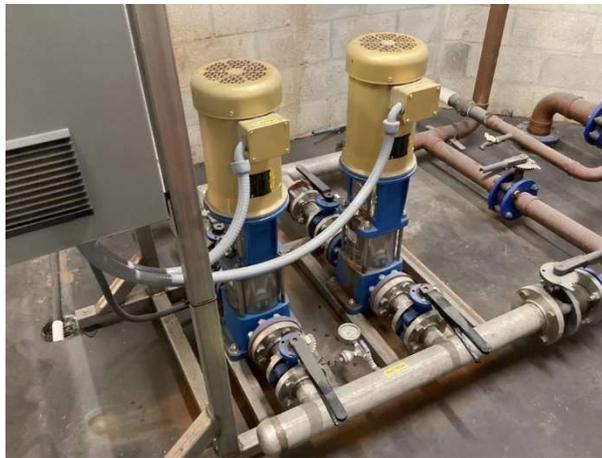
**Domestic water pumps**

**History:** Installed in 2020. Management and the Board inform us one pump is being replaced in 2023 due to damages from a power surge

**Condition:** Reported satisfactory without operational deficiencies.

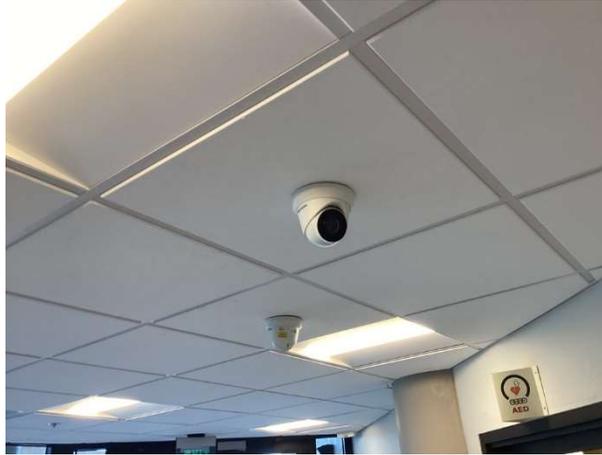
**Security system camera**

**Condition:** Reported satisfactory without operational deficiencies

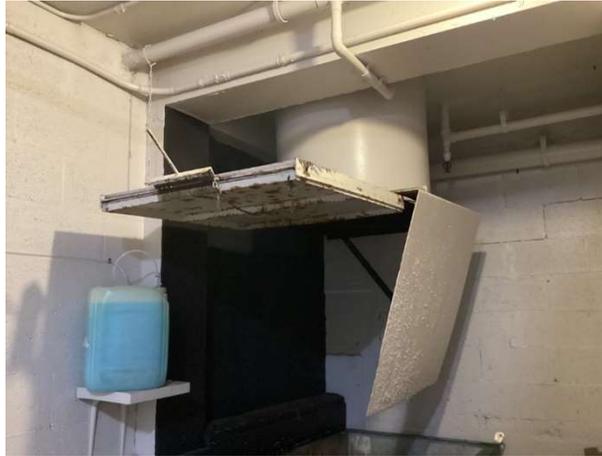
**Trash chute**

**Condition:** Reported satisfactory without operational deficiencies

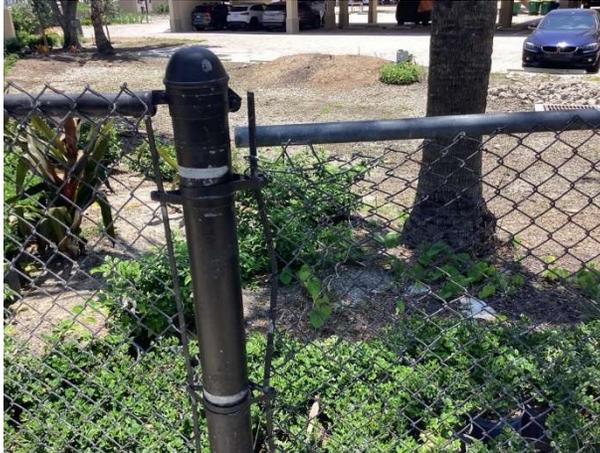
**Fence warped webbing**

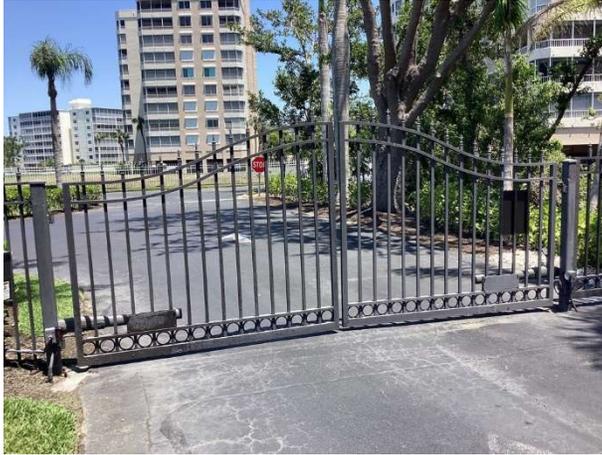
**Aluminum gates**

**Condition:** Good overall condition

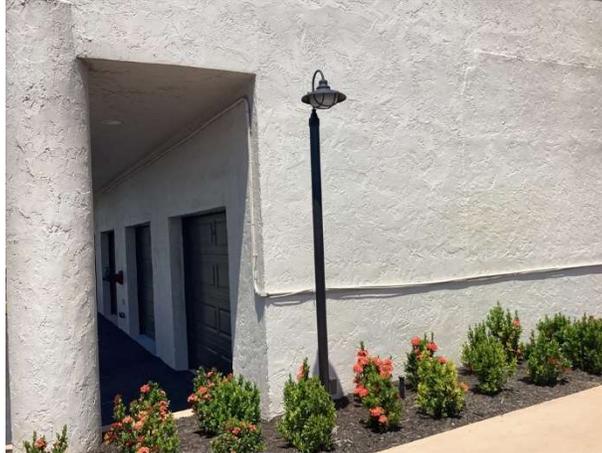
**Light pole and fixture**

**Condition:** Good overall

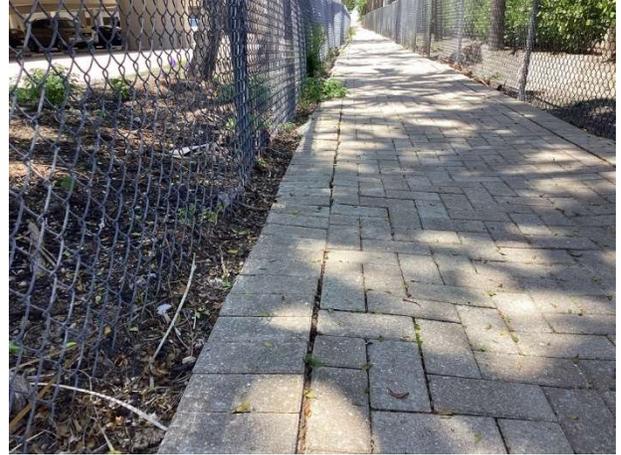
**Dislodged pavers at beach access walkway**

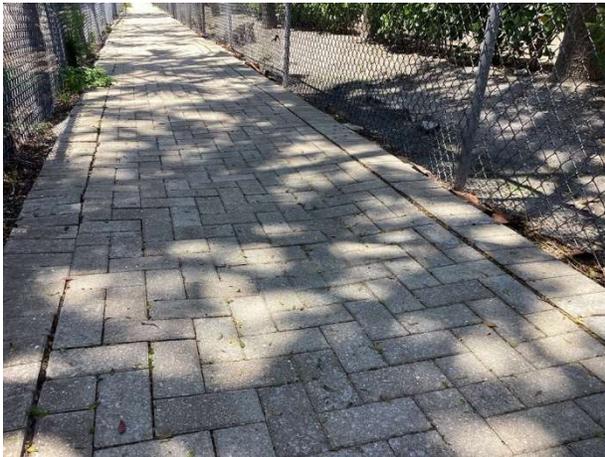
**Paver settlement at beach access walkway**

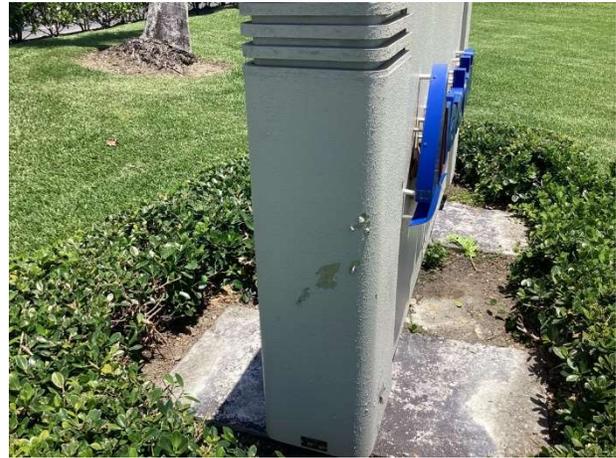
**Peeling paint finishes**

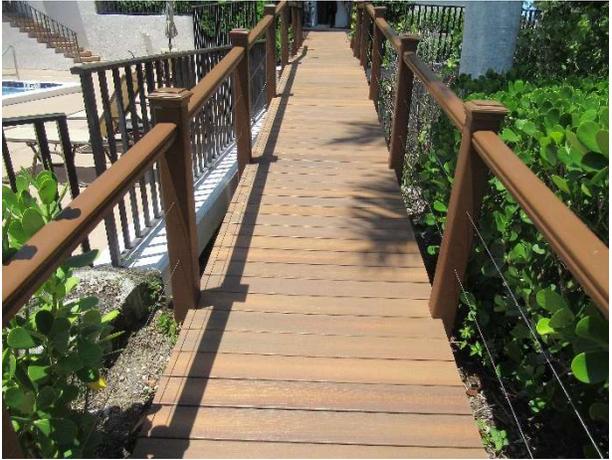
**Walkway overview**

**Condition:** Good condition

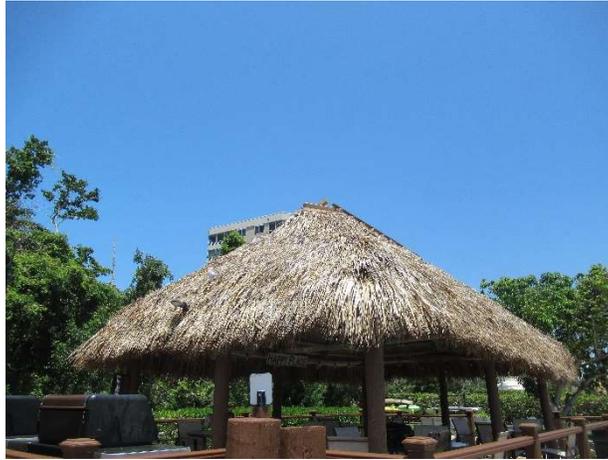
**Tiki hut roof**

**Condition:** Good overall

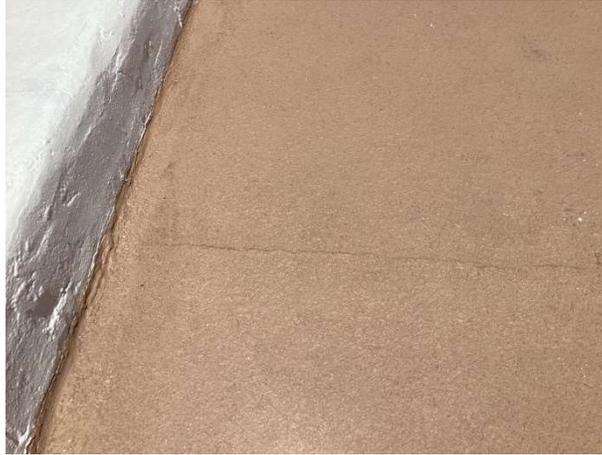
**Condition:** Good to fair overall

#### **Concrete cracks**

**Useful Life:** The useful life of a concrete pool deck is up to 60 years or more with timely repairs. We recommend the Association conduct inspections, partial replacements and repairs to the deck every 8- to 12-years in conjunction with coating replacements.

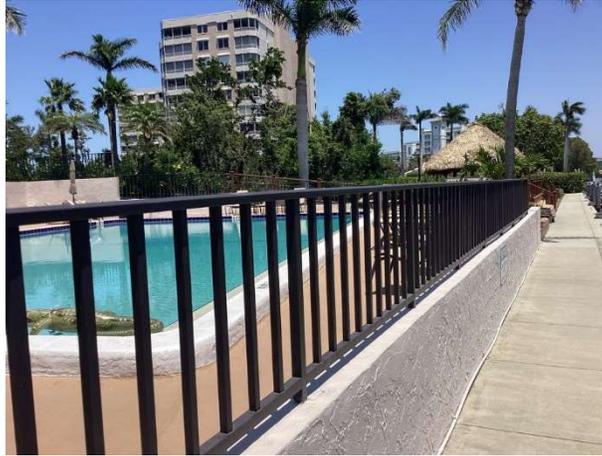
**Aluminum pool fence**

**Condition:** Good overall

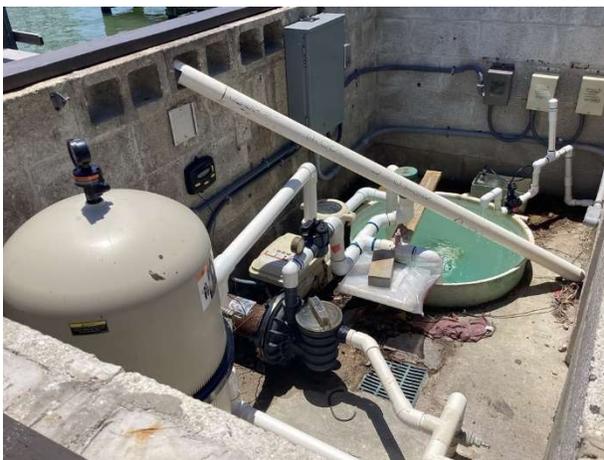
**Pool mechanical equipment**

**Condition:** Reported satisfactory without operational deficiencies

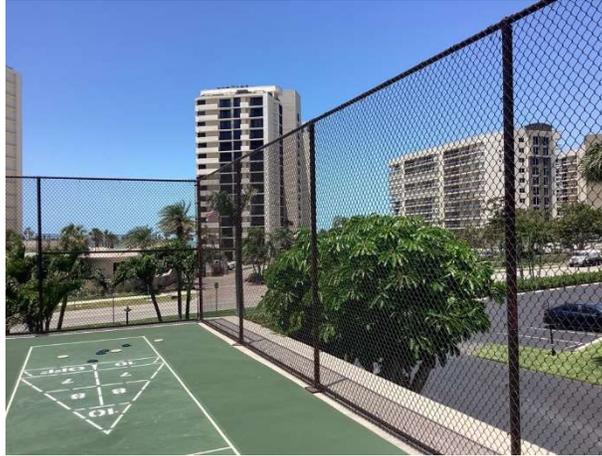
**Chain link fence**

**Condition:** Good overall
